**Flood Control Project Maintenance  
Levee Inspections****LMA District Cover Sheet****Spring 2014 Levee Inspection Results****Sacramento River West Side Levee District**

**Spring 2014 Levee Inspection Results**

**Sacramento River West Side Levee District**

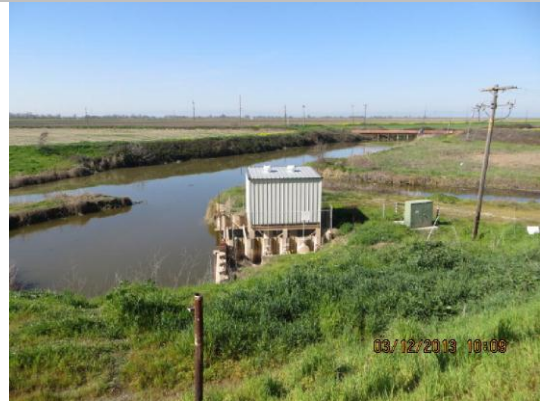
Photo 1 of 1 : UCIP\_278.jpg

LM Start	0.14	Rating **	M	Issue No.	4
LM End	0.14	Issue Type +	En	Location *	WS
Category	Supplemental			GPS Latitude/Longitude	
				Start	End
Item	DWR UCIP Field Study			38.801471 °	38.801471 °
				-121.725171 °	-121.725171 °
DWR ID	DWR_NA0016_01_s _ 2014_4				
Action/Comments					
Inspector Comments: FS_ID:10087					
EP_NO: N/A					
Repair Type:					
Crossing Status:					
UCIP Comments: Headwall on WS undermined about 3-4-feet.					
FIELD_STRUCT_DESC: 1 of 3: 36-inch steel drainage pipe through					
levee 30.0 feet below crown. Flap gate on the waterward end. 24-inch					
pipe sleeved through the 36-inch pipe. Annular space between pipes					
grouted. Pumps in pumphouse with walkway on LS toe. Originally					
included in the 1960 O&M manual.					
FS Date: 3/12/2013

Pumphouse at LS toe.

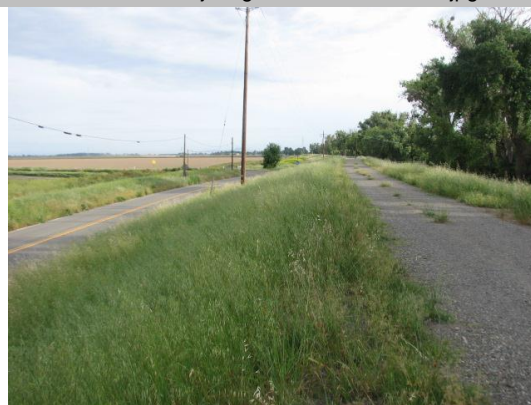
Photo 1 of 1 : johngw\_s\_20140428\_864.jpg

Tall grasses partially blocks visibility. Spring 2014

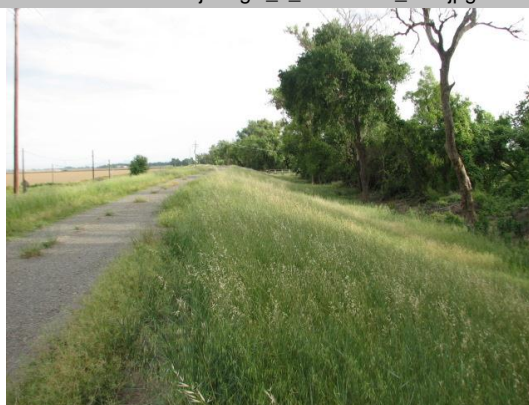
Photo 1 of 1 : johngw\_s\_20140428\_865.jpg

Tall grasses partially blocks visibility. Spring 2014

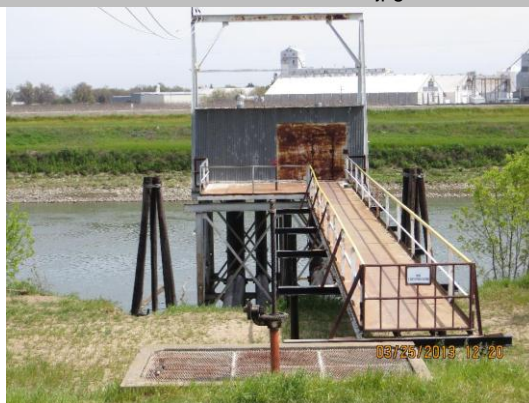
Photo 1 of 1 : UCIP\_281.jpg

LM Start	0.46	Rating **	M	Issue No.	36
LM End	0.46	Issue Type +	En	Location *	WS
Category	Supplemental			GPS Latitude/Longitude	
				Start	End
Item	DWR UCIP Field Study			38.805353 °	38.805353 °
				-121.724207 °	-121.724207 °
DWR ID	DWR_NA0016_01_s _ 2014_36				
Action/Comments					
Inspector Comments: FS_ID:10103 EP_NO: 1331 Repair Type: Crossing Status: UCIP Comments: There is no gate in the slide gate at the concrete distribution box off the landside toe. This may not be an issue as there is a slide gate at the WS toe. FIELD_STRUCT_DESC: 54-inch corrugated metal irrigation pipe through levee 28.0 feet below crown. Vertical pumps on pile structure in the stream, walkway to pumps. Flap gates from pumps and slide gate inside a 7'X10-foot concrete surge box on the waterward side, 1948 installation. 15'X18-foot concrete distribution box 150-feet off landside toe with slide gate. (Permit No. 1331, 1948). Included in 1960 O&M manual. FS Date: 3/25/2013 7:36:51 AM

Pumping plant with concrete surge box and slide gate in foreground-off WS toe.

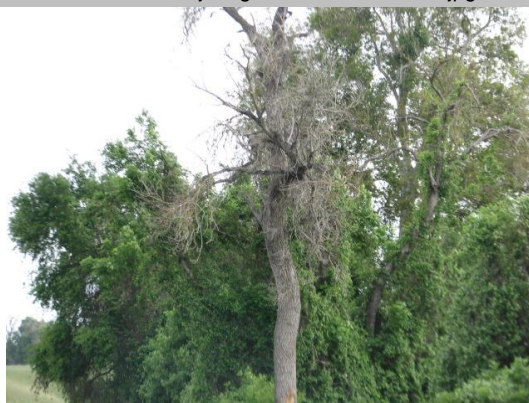
Photo 1 of 1 : johngw\_s\_20140428\_867.jpg

Monitor trees that pose a future threat to the integrity of the levee. Spring 2014

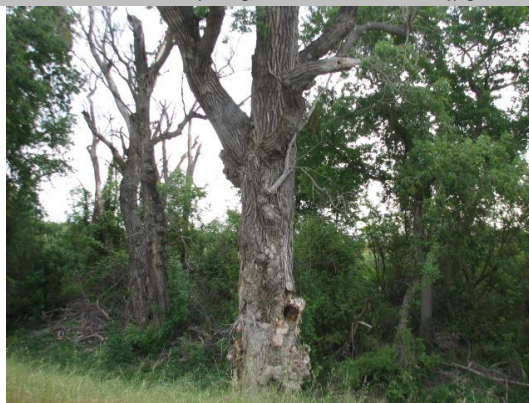
Photo 1 of 1 : johngw\_s\_20140428\_868.jpg

LM Start	1.88	Rating **	A/W	Issue No.	84
LM End	1.88	Issue Type +	Ma	Location *	WS
Category	Earthen Levee			GPS Latitude/Longitude	
				Start	End
Item	Vegetation			38.825534 °	38.825534 °
				-121.724749 °	-121.724749 °
DWR ID	DWR_NA0016_01_s _ 2014_84				
Action/Comments					
Trees / Woody Vegetation

Monitor trees that pose a future threat to the integrity of the levee. Spring 2014

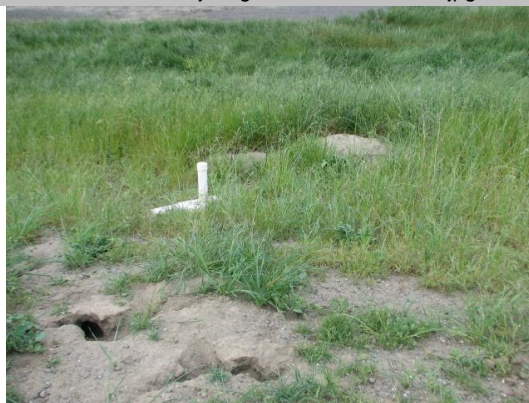
Photo 1 of 1 : johngw\_s\_20140428\_870.jpg

Bait station near rodent holes. Rodent holes need to be backfilled.  
Spring 2014

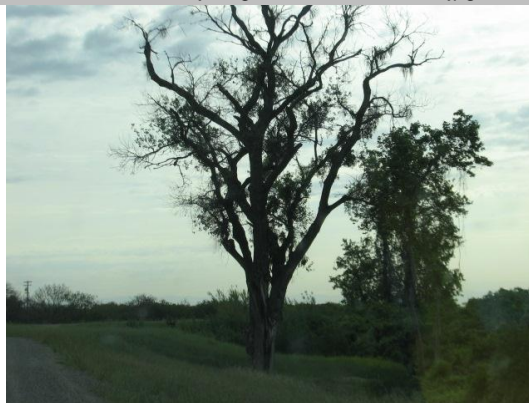
Photo 1 of 1 : johngw\_s\_20140428\_871.jpg

Monitor trees that pose a future threat to the integrity of the levee.  
Spring 2014**\* Location**

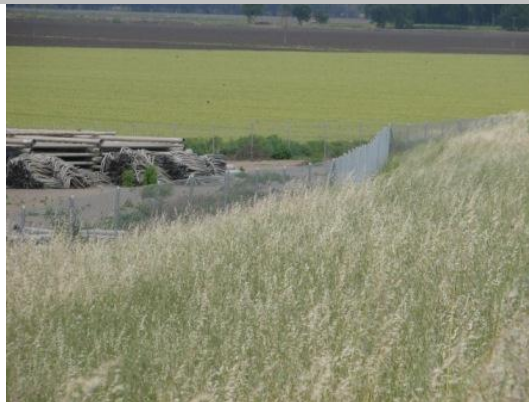
Photo 1 of 1 : johngw\_s\_20140414\_728.jpg

The chain link fence runs along the toe but does not obstruct the view.  
Photo taken spring 2012.

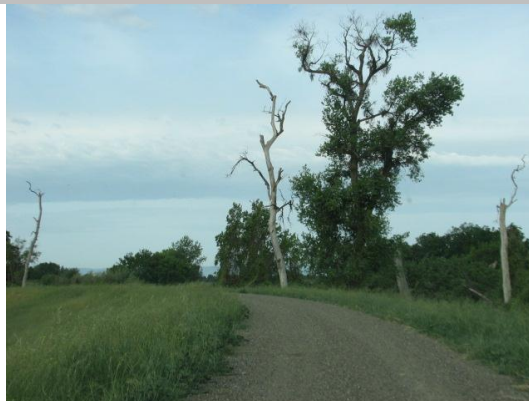
Photo 1 of 1 : johngw\_s\_20140428\_873.jpg

Monitor trees that may pose a future threat to the integrity of the levee.  
Spring 2014

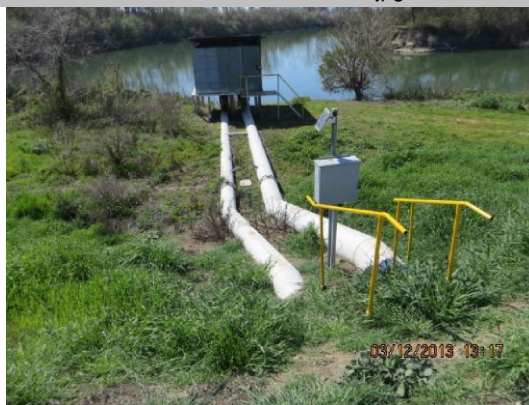
Photo 1 of 1 : UCIP\_285.jpg

LM Start	6.89	Rating **	M	Issue No.	37
LM End	6.89	Issue Type +	En	Location *	WS
Category	Supplemental			GPS Latitude/Longitude	
				Start	End
Item	DWR UCIP Field Study			38.864862 °	38.864862 °
				-121.757516 °	-121.757516 °
DWR ID	DWR_NA0016_01_s _ 2014_37				
Action/Comments					
Inspector Comments: FS_ID:10129					
EP_NO: 1297					
Repair Type:					
Crossing Status:					
UCIP Comments: Leak at flowmeter on WS berm may become problem in near future.					
FIELD_STRUCT_DESC: 2 of 2: 16-inch steel pipe through levee 5.2 feet below crown. Slant pumps in metal pump house on the waterward bank, supported on steel structure. Pipes discharge into 9.5'x12' concrete distribution box on the landward side. Sparline flow meter on pipes near the waterward toe. (Permit No. 1297, 1948). Also included in the 1960 O&M manual and ABO No. 8501.					
FS Date: 3/12/2013

Pumphouse and steps on WS.

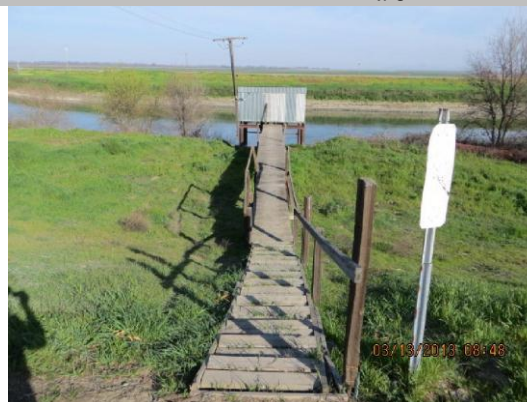
Photo 1 of 1 : UCIP\_294.jpg

LM Start	7.94	Rating **	M	Issue No.	38
LM End	7.94	Issue Type +	En	Location *	WS
Category	Supplemental			GPS Latitude/Longitude	
				Start	End
Item	DWR UCIP Field Study			38.861018 °	38.861018 °
				-121.769651 °	-121.769651 °
DWR ID	DWR_NA0016_01_s_2014_38				
Action/Comments					
Inspector Comments: FS_ID:10144					
EP_NO: 18206					
Repair Type:					
Crossing Status:					
UCIP Comments: Flap gates rusted through at concrete distribution box on LS toe.					
FIELD_STRUCT_DESC: 1 of 2: 20-inch steel pipe through levee 4.7 feet below crown (Permit No. 18206, 2007). Two slant pumps in pump house on the waterward berm. Siphon breakers in corrugated metal riser units on the shoulder. Flap gate on both pipes in concrete distribution box on the landward side. Wooden steps on both slopes. Replaced 20-inch pipe installed under Permit No. 9377.					
FS Date: 3/13/2013

Stairs and pump on WS.

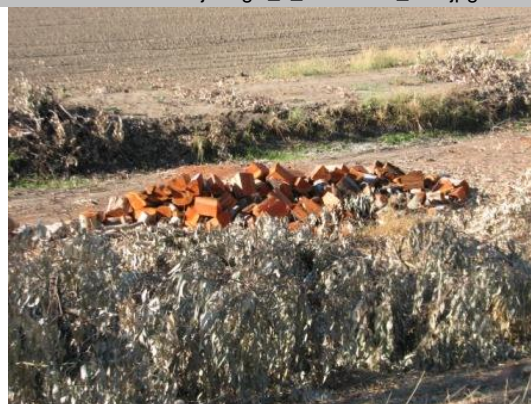
Photo 1 of 3 : johngw\_s\_20140414\_774.jpg

Firewood stacked along the toe of the levee. Fall 2013

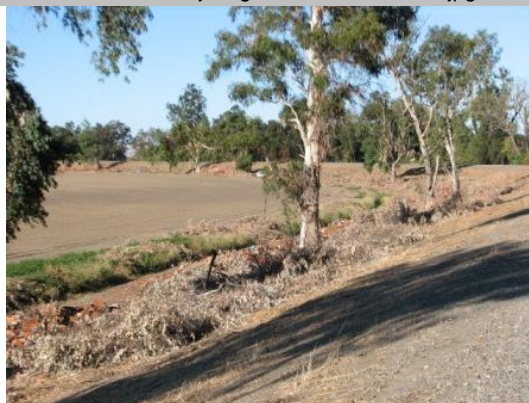
Photo 2 of 3 : johngw\_s\_20140414\_775.jpg

Firewood and brush along the toe of the levee. Removal and thinning trees at the toe. Fall 2013

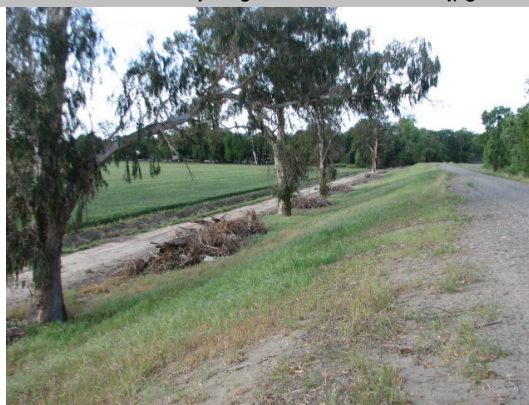
Photo 3 of 3 : johngw\_s\_20140428\_874.jpg

LM Start	<b>8.15</b>	Rating **	M	Issue No.	<b>1554 (cont)</b>
LM End	<b>8.74</b>	Issue Type +	En	Location *	LS

Tree thinning and firewood stacked along the toe of the levee. Spring 2014

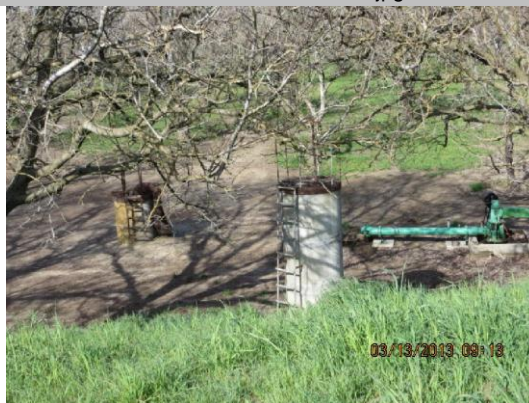
Photo 1 of 1 : UCIP\_300.jpg

LM Start	9.31	Rating **	M	Issue No.	40
LM End	9.31	Issue Type +	En	Location *	LS
Category	Supplemental			GPS Latitude/Longitude	
				Start	End
Item	DWR UCIP Field Study			38.860993 °	38.860993 °
				-121.784840 °	-121.784840 °
DWR ID	DWR_NA0016_01_s _ 2014_40				
Action/Comments					
Inspector Comments: FS_ID:10150					
EP_NO: 1641					
Repair Type:					
Crossing Status:					
UCIP Comments: Meter removed from pipe on WS and pipe open.					
Appears abandoned. Pipe should be abandoned properly.					
FIELD_STRUCT_DESC: 14-inch steel pipe through levee 5.2 feet					
below crown. Pump on concrete pump platform on the bank. Siphon					
breaker on the landward slope. Sparling flow meter on pipe on the					
waterward slope. 42 inch concrete standpipe in concrete distribution					
box at the landward toe. (Permit No. 1641, 1959). Included in the 1960					
O&M Manual.					
FS Date: 3/13/2013

Concrete riser on LS toe.

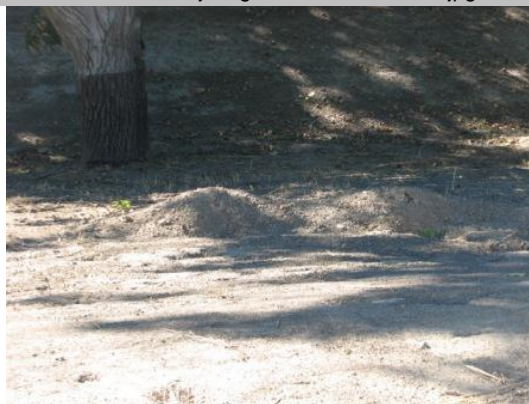
Photo 1 of 1 : johngw\_s\_20140414\_776.jpg

LM Start	9.72	Rating **	M	Issue No.	1555
LM End	9.72	Issue Type +	Ma	Location *	LS
Category	Earthen Levee			GPS Latitude/Longitude	
				Start	End
Item	Animal Control			38.862457 °	38.862457 °
				-121.790273 °	-121.790273 °
DWR ID	DWR_NA0016_01_f_2013_1555				
Action/Comments					
Repair the levee slope damaged by livestock and prevent large animal access.

Serval rodent holes at the toe of the levee. Fall 2013

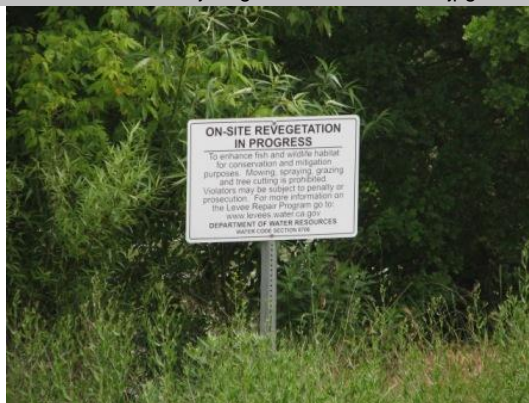
Photo 1 of 2 : johngw\_s\_20140414\_756.jpg

Revegetation site. Photo taken spring 2012.

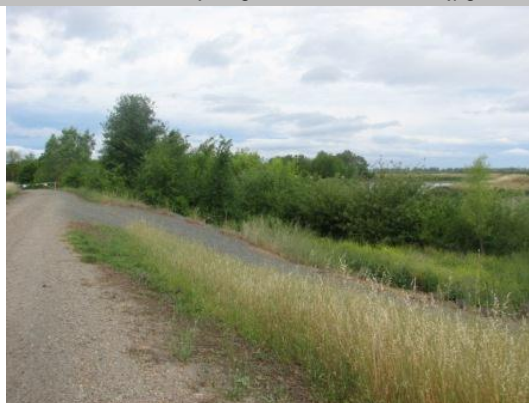
Photo 2 of 2 : johngw\_s\_20140414\_757.jpg

LM Start	<b>9.78</b>	Rating **	A/W	Issue No.	<b>29 (cont)</b>
LM End	<b>9.90</b>	Issue Type +	Ma	Location *	WS

The revegetation site along the berm.

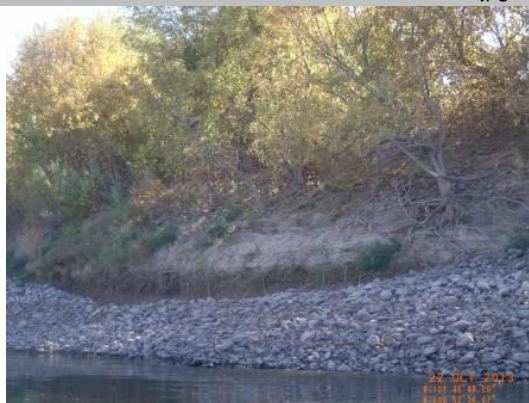
Photo 1 of 1 : USACE2013A\_SAC\_101-3\_R\_3.jpg

LM Start	10.03	Rating **	M	Issue No.	1
LM End	11.51	Issue Type +	Ma	Location *	WS
Category	Supplemental			GPS Latitude/Longitude	
				Start	End
Item	USACE Erosion Survey			38.875109 °	38.874854 °
				-121.813592 °	-121.813018 °
DWR ID					
Action/Comments					
Inspector Comments: 1997 - Toe damage and loss of cobble revetment

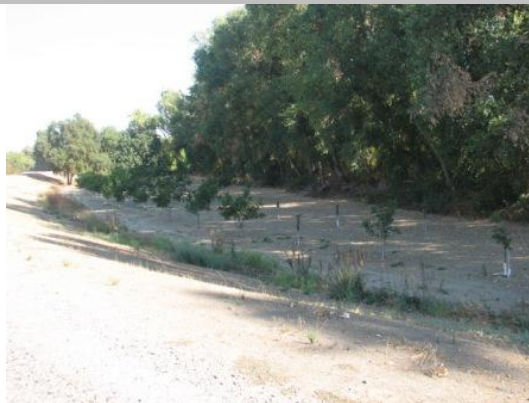
Photo 1 of 1 : johngw\_s\_20140414\_768.jpg

Walnut orchard planted on the waterside berm. Fall 2012

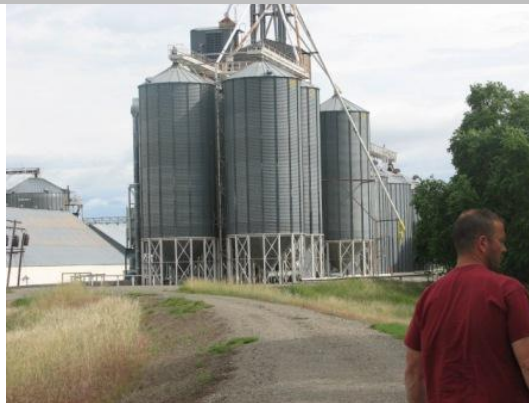
Photo 1 of 1 : johngw\_s\_20140414\_739.jpg

LM Start	12.35	Rating **	A/W	Issue No.	14
LM End	12.35	Issue Type +	Ma	Location *	CR
Category	Earthen Levee			GPS Latitude/Longitude	
				Start	End
Item	Encroachments			38.883807 °	38.883807 °
				-121.817543 °	-121.817543 °
DWR ID	DWR_NA0016_01_s _ 2012_14				
Action/Comments					
Building

The rice silos are on top of the levee crown. Photo taken spring 2012.

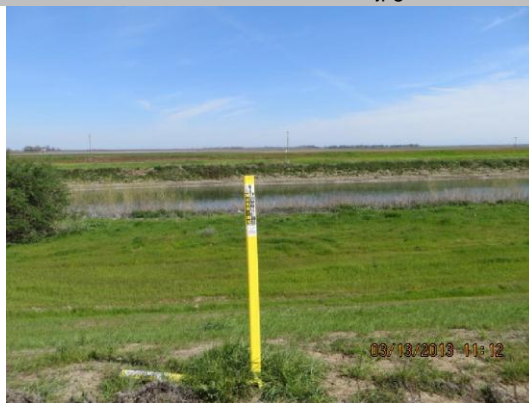
Photo 1 of 1 : UCIP\_302.jpg

LM Start	16.39	Rating **	M	Issue No.	44
LM End	16.39	Issue Type +	En	Location *	CR
Category	Supplemental			GPS Latitude/Longitude	
				Start	End
Item	DWR UCIP Field Study			38.923407 °	38.923407 °
				-121.834588 °	-121.834588 °
DWR ID	DWR_NA0016_01_s _ 2014_44				
Action/Comments					
Inspector Comments: FS_ID:10203					
EP_NO: N/A					
Repair Type:					
Crossing Status:					
UCIP Comments: Need to determine if this is a permitted crossing as it was not previously noted. Need to determine size and depth below the crown.					
FIELD_STRUCT_DESC: Gas line through levee at unknown depth below the crown. Marker on WS shoulder.					
FS Date: 3/13/2013

Gasline marker on WS shoulder.

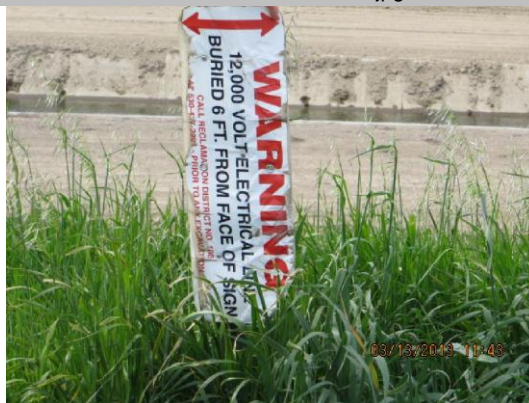
Photo 1 of 1 : UCIP\_454.jpg

LM Start	18.10	Rating **	M	Issue No.	45
LM End	18.10	Issue Type +	En	Location *	CR
Category	Supplemental			GPS Latitude/Longitude	
				Start	End
Item	DWR UCIP Field Study			38.942979 °	38.942979 °
				-121.837030 °	-121.837030 °
DWR ID	DWR_NA0016_01_s _ 2014_45				
Action/Comments					
Inspector Comments: FS_ID:11323					
EP_NO: 18026					
Repair Type:					
Crossing Status:					
UCIP Comments: Conduit needs to be located and signs installed where it crosses the levee crown.					
FIELD_STRUCT_DESC: Electric Conduit through the levee at unknown depth. Signage on LS shoulder. (Permit No. 18026, 2007)					
FS Date: 3/13/2013

Sign on LS shoulder.

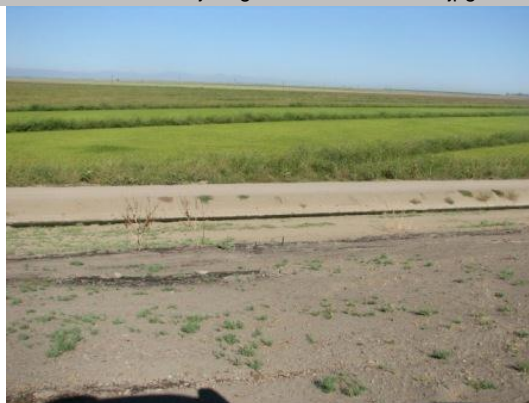
Photo 1 of 1 : johngw\_s\_20140414\_740.jpg

A concrete lined ditch. Fall 2012

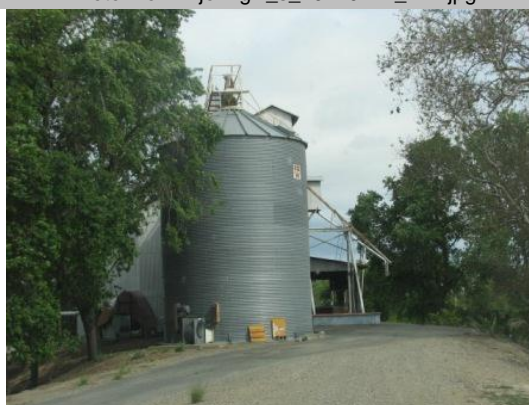
Photo 1 of 1 : johngw\_s\_20140414\_741.jpg

LM Start	18.75	Rating **	A/W	Issue No.	16
LM End	18.75	Issue Type +	Ma	Location *	CR
Category	Earthen Levee			GPS Latitude/Longitude	
				Start	End
Item	Encroachments			38.951400 °	38.951400 °
				-121.838255 °	-121.838255 °
DWR ID	DWR_NA0016_01_s _ 2012_16				
Action/Comments					
Building

Another rice mill on the crown. Photo taken spring 2012.

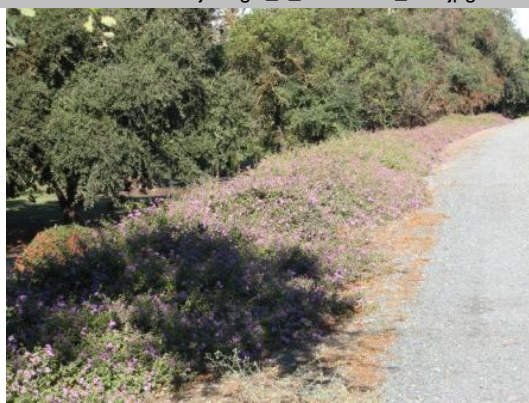
Photo 1 of 1 : johngw\_s\_20140414\_744.jpg

LM Start	18.89	Rating **	M	Issue No.	18
LM End	18.89	Issue Type +	En	Location *	LS
Category	Earthen Levee			GPS Latitude/Longitude	
				Start	End
Item	Vegetation			38.952925 °	38.952925 °
				-121.840010 °	-121.840010 °
DWR ID	DWR_NA0016_01_s _ 2012_18				
Action/Comments					
Landscaping

Groundcover and trees with irrigation are planted on the levee slope. Fall 2011.

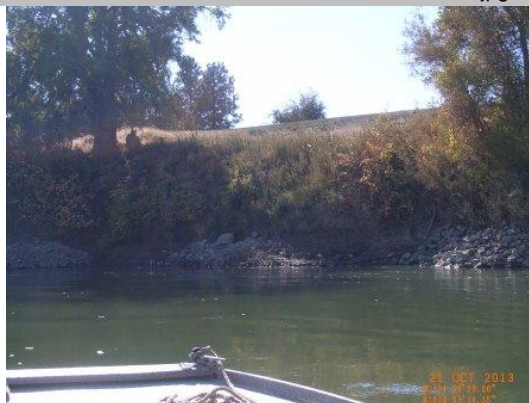
Photo 1 of 1 : USACE2013A\_SAC\_111-0\_R\_1.jpg

LM Start	18.98	Rating **	M	Issue No.	2
LM End	18.98	Issue Type +	Ma	Location *	WS
Category	Supplemental			GPS Latitude/Longitude	
				Start	End
Item	USACE Erosion Survey			38.954060 °	38.954312 °
				-121.840560 °	-121.840774 °
DWR ID					
Action/Comments					
Inspector Comments: 2009 - Minor erosion, should be repaired under maintenance. 2011 - Some new minor erosion at the toe. 2013: No observed changes. [2013 Site ID: SAC_111-0_R]

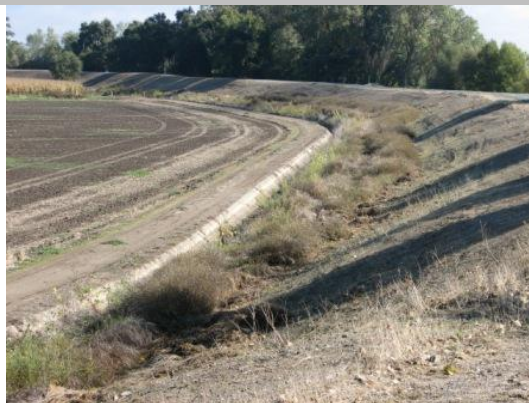
Photo 1 of 1 : johngw\_s\_20140414\_760.jpg

The concrete lined agricultural ditch runs along the toe. Fall 2011.

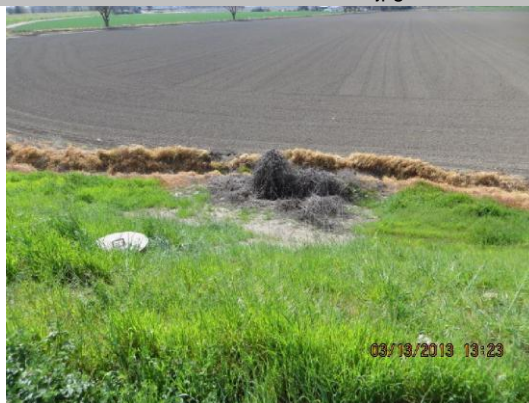
Photo 1 of 1 : UCIP\_304.jpg

LM Start	19.72	Rating **	M	Issue No.	48
LM End	19.72	Issue Type +	En	Location *	LS
Category	Supplemental			GPS Latitude/Longitude	
				Start	End
Item	DWR UCIP Field Study			38.961221 °	38.961221 °
				-121.833230 °	-121.833230 °
DWR ID	DWR_NA0016_01_s _ 2014_48				
Action/Comments					
Inspector Comments: FS_ID:10253					
EP_NO: 1507					
Repair Type:					
Crossing Status:					
UCIP Comments: Pipe appears abandoned. Needs to be abandoned properly.					
FIELD_STRUCT_DESC: 14-inch steel irrigation pipe through levee 8.4 feet below crown. Gate valve on the waterward side, siphon breaker in 24-inch CMP riser on the landward slope. Concrete distribution box in irrigation ditch at the toe of the landward slope (Permit No. 1507, 1959). Included in the 1960 O&M manual.					
FS Date: 3/13/2013

CMP Riser on shoulder and concrete distribution box under heavy blackberry cover at LS toe.

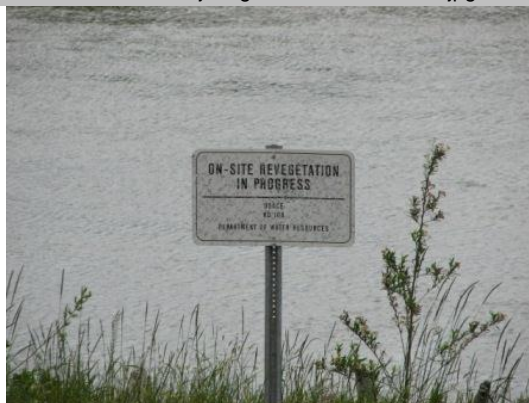
Photo 1 of 2 : johngw\_s\_20140414\_758.jpg

Revegetation site. Photo taken spring 2012.

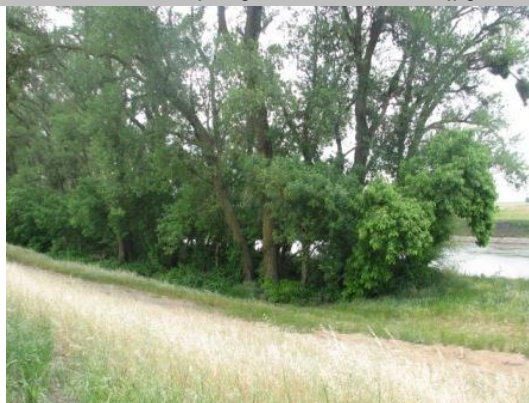
Photo 2 of 2 : johngw\_s\_20140414\_759.jpg

The revegetation site on the berm.

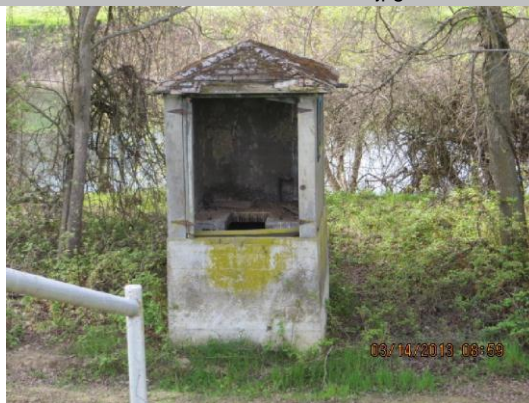
Photo 1 of 1 : UCIP\_311.jpg

Concrete pumphouse on WS berm.

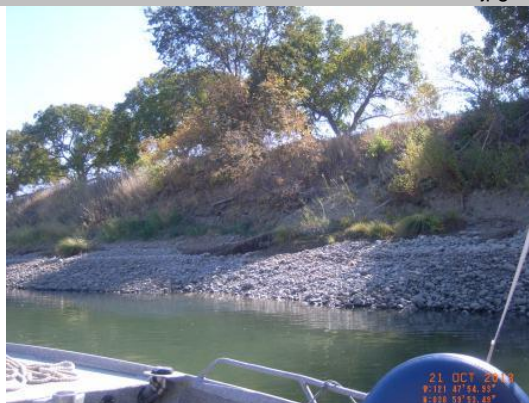
Photo 1 of 1 : USACE2013A\_SAC\_115-9\_R\_5.jpg

LM Start	23.69	Rating **	M	Issue No.	3
LM End	23.69	Issue Type +	Ma	Location *	WS
Category	Supplemental			GPS Latitude/Longitude	
				Start	End
Item	USACE Erosion Survey			38.997696 °	38.998336 °
				-121.797584 °	-121.799298 °
DWR ID					
Action/Comments					
Inspector Comments: 2008 - Slippage of cobbles off hard underlying toe material. 2011 - Minor slumping site. 2012 - Failing cobble site, site extended upstream. 2013: No observed changes. [2013 Site ID: SAC_115-9_R]

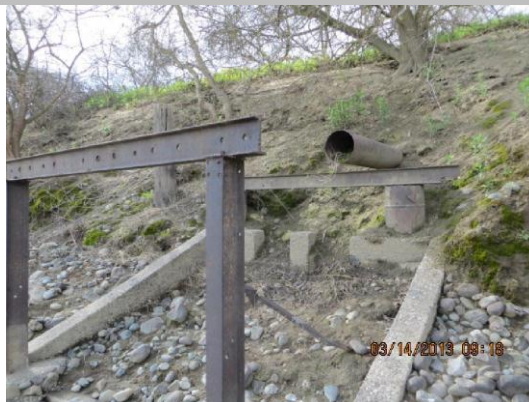
Photo 1 of 1 : UCIP\_305.jpg

LM Start	23.98	Rating **	M	Issue No.	50
LM End	23.98	Issue Type +	En	Location *	WS
Category	Supplemental			GPS Latitude/Longitude	
				Start	End
Item	DWR UCIP Field Study			38.998247 °	38.998247 °
				-121.800235 °	-121.800235 °
DWR ID	DWR_NA0016_01_s _ 2014_50				
Action/Comments					
Inspector Comments: FS_ID:10261					
EP_NO: 9374					
Repair Type:					
Crossing Status:					
UCIP Comments: Appears abandoned. Pipe should be properly abandoned.					
FIELD_STRUCT_DESC: 1 of 4: 36-inch corrugated metal pipe through levee 20.0 feet below crown. One corrugated metal cutoff wall installed by United States Army Corp of Engineers, 1955. Slide gate in 36-inch corrugated metal riser on the waterward slope. Pump on the waterward bank. Concrete standpipe at toe of the landward slope (ABO No. 9374, 1974). Originally included in the 1960 O&M manual.					
FS Date: 3/14/2013

abandoned pump platform on Rivers edge.

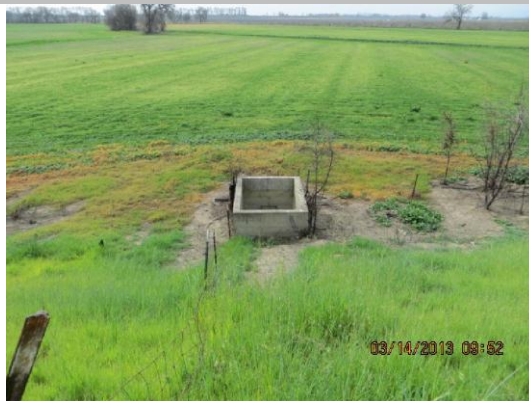
Photo 1 of 1 : UCIP\_308.jpg

LM Start	25.02	Rating **	M	Issue No.	51
LM End	25.02	Issue Type +	En	Location *	WS
Category	Supplemental			GPS Latitude/Longitude	
				Start	End
Item	DWR UCIP Field Study			39.005097 °	39.005097 °
				-121.816116 °	-121.816116 °
DWR ID	DWR_NA0016_01_s_2014_51				
Action/Comments					
Inspector Comments: FS_ID:10265					
EP_NO: 9328					
Repair Type:					
Crossing Status:					
UCIP Comments: Appears abandoned. Needs to be abandoned properly.					
FIELD_STRUCT_DESC: 24-inch corrugated metal pipe through levee 20.0 feet below crown. Slide gate in 36-inch corrugated metal riser unit on the waterward slope. 7'X9' Distribution box at toe of the landward slope (ABO. No. 9328, 1960)					
FS Date: 3/14/2013

7-foot by 9-foot distribution box at LS toe.

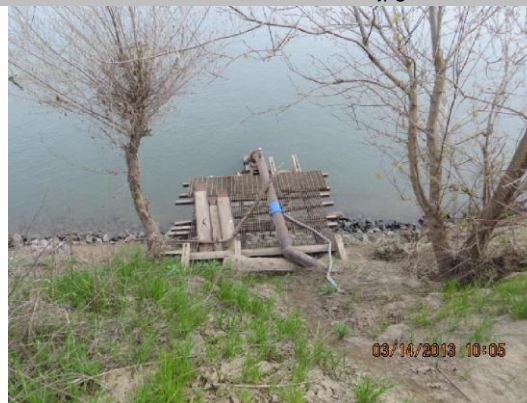
Photo 1 of 1 : UCIP\_312.jpg

LM Start	25.31	Rating **	M	Issue No.	52
LM End	25.31	Issue Type +	En	Location *	LS
Category	Supplemental			GPS Latitude/Longitude	
				Start	End
Item	DWR UCIP Field Study			39.006538 °	39.006538 °
				-121.821058 °	-121.821058 °
DWR ID	DWR_NA0016_01_s_2014_52				
Action/Comments					
Inspector Comments: FS_ID:10267					
EP_NO: 9330					
Repair Type:					
Crossing Status:					
UCIP Comments: Possible sink hole over pipe alignment on WS berm at rivers edge. general condition of pipe and appurtances in disrepair. FIELD_STRUCT_DESC: 10-inch pipe through levee 12.3 feet below crown. 6-inch pipe discharges into 10-inch pipe on waterward end, portable pump and gate valve on waterward side. Power pole and anchor on waterward shoulder and toe (ABO No. 9330, 1960). Originally included in the 1960 O&M manual.					
FS Date: 3/14/2013

Pump platform on WS slope..

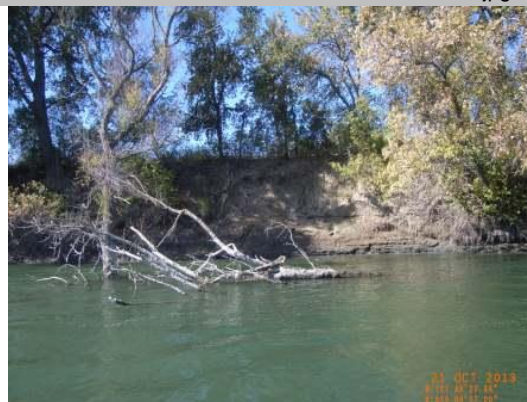
Photo 1 of 1 : USACE2013A\_SAC\_118-0\_R\_2.jpg

LM Start	26.05	Rating **	M	Issue No.	7
LM End	26.05	Issue Type +	Ma	Location *	WS
Category	Supplemental			GPS Latitude/Longitude	
				Start	End
Item	USACE Erosion Survey			39.014499 °	39.016401 °
				-121.825880 °	-121.824230 °
DWR ID					
Action/Comments					
Inspector Comments: 2008 - Whole bank is eroding, nearly vertical slope with cohesive toe. Bed is very deep along the toe (greater than 30 ft deep at 20 ft from the shore). 2011 - Some new minor erosion. 2013: No observed changes. [2013 Site ID: SAC_118-0_R]

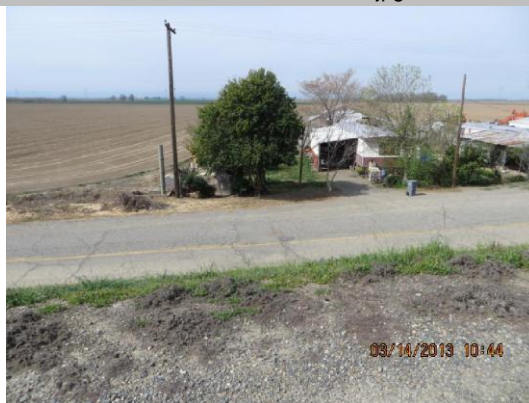
Photo 1 of 1 : UCIP\_318.jpg

LM Start	26.77	Rating **	M	Issue No.	53
LM End	26.77	Issue Type +	En	Location *	WS
Category	Supplemental			GPS Latitude/Longitude	
				Start	End
Item	DWR UCIP Field Study			39.023842 °	39.023842 °
				-121.823077 °	-121.823077 °
DWR ID	DWR_NA0016_01_s _ 2014_53				
Action/Comments					
Inspector Comments: FS_ID:10285					
EP_NO: 9136					
Repair Type:					
Crossing Status:					
UCIP Comments: Pipe appears to be abandoned. Pipe needs to be abandoned properly.					
FIELD_STRUCT_DESC: 18-inch steel pipe through levee 3.0 feet below crown. Steel cutoff wall at centerline. Air release valve on the waterward shoulder (Permit No. 9136, 1974). Slide gate in 72-inch diameter CMP riser on LS toe.					
FS Date: 3/14/2013

72-inch CMP riser on LS toe under JP next to tree.

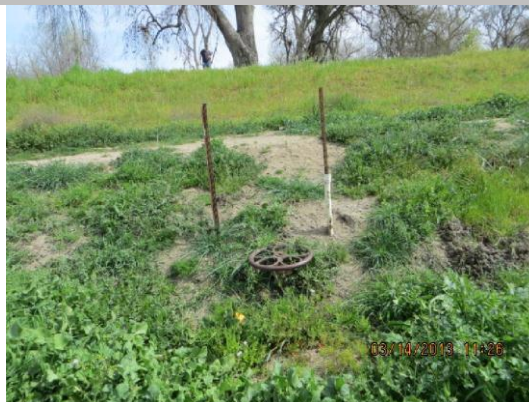
Photo 1 of 1 : UCIP\_322.jpg

LM Start	27.78	Rating **	M	Issue No.	55
LM End	27.78	Issue Type +	En	Location *	WS
Category	Supplemental			GPS Latitude/Longitude	
				Start	End
Item	DWR UCIP Field Study			39.033766 °	39.033766 °
				-121.833110 °	-121.833110 °
DWR ID	DWR_NA0016_01_s _ 2014_55				
Action/Comments					
Inspector Comments: FS_ID:10289					
EP_NO: 9368					
Repair Type:					
Crossing Status:					
UCIP Comments: Need to abandon pipe properly.					
FIELD_STRUCT_DESC: 24-inch steel pipe through levee 16.2 feet below crown (ABO No. 9368, 1960) Pump on the waterward bank. Gate valve on the landward end. Concrete box at the landward toe of the slope. Irrigation well 6 feet from toe of landward slope. Originally included in the 1960 O&M manual with the description standpipe on waterward side.					
FS Date: 3/14/2013

gate valve off landside toe.

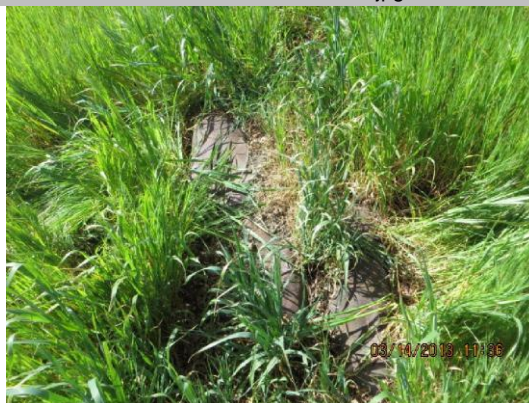
Photo 1 of 1 : UCIP\_324.jpg

LM Start	27.79	Rating **	M	Issue No.	56
LM End	27.79	Issue Type +	En	Location *	WS
Category	Supplemental			GPS Latitude/Longitude	
				Start	End
Item	DWR UCIP Field Study			39.033814 °	39.033814 °
				-121.833158 °	-121.833158 °
DWR ID	DWR_NA0016_01_s _ 2014_56				
Action/Comments					
Inspector Comments: FS_ID:10290					
EP_NO: N/A					
Repair Type:					
Crossing Status:					
UCIP Comments: Appears this pipe is abandoned and visible on WS slope in pieces. Need to verify proper abandonment.					
FIELD_STRUCT_DESC: 24-inch pipe through levee 6.2 feet below crown. Originally included in the 1960 O&M manual. Pipe debris on WS slope.					
FS Date: 3/14/2013

Pipe debris on WS slope.

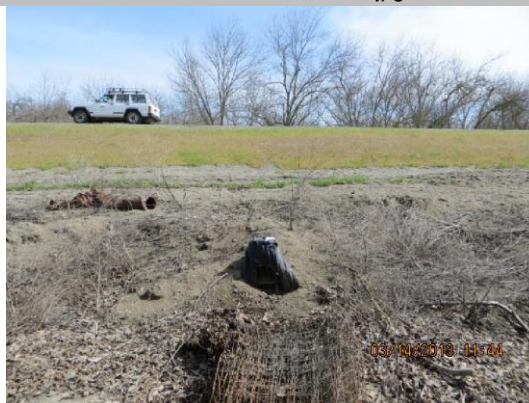
Photo 1 of 1 : UCIP\_327.jpg

LM Start	27.87	Rating **	M	Issue No.	57
LM End	27.87	Issue Type +	En	Location *	WS
Category	Supplemental			GPS Latitude/Longitude	
				Start	End
Item	DWR UCIP Field Study			39.034870 °	39.034870 °
				-121.833501 °	-121.833501 °
DWR ID	DWR_NA0016_01_s _ 2014_57				
Action/Comments					
Inspector Comments: FS_ID:10291					
EP_NO: 9355					
Repair Type:					
Crossing Status:					
UCIP Comments: Pipe needs to be properly abandoned.					
FIELD_STRUCT_DESC: 24-inch steel pipe through levee 14.0 feet below crown. Slide gate on the waterward end, gate valve on the landward end (ABO No. 9355, 1960). Originally included in the 1960 O&M manual.					
FS Date: 3/14/2013

Gate valve buried on LS toe.

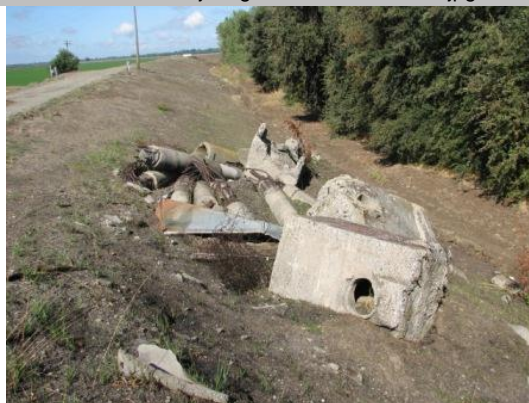
Photo 1 of 2 : johngw\_s\_20140414\_766.jpg

Concrete debris is on the waterside levee slope. Fall 2011.

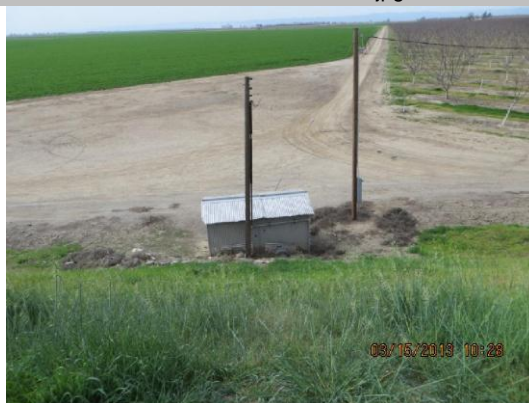
Photo 1 of 1 : UCIP\_333.jpg

Pumphouse at LS toe.

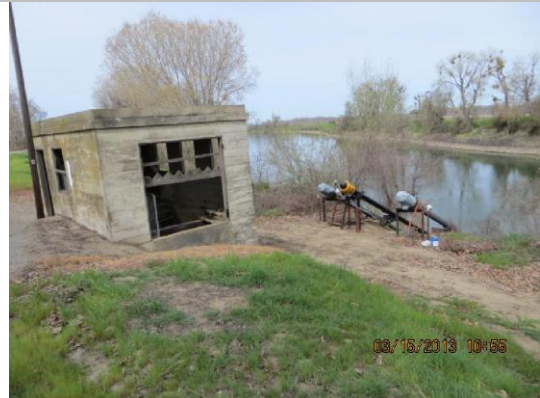
Photo 1 of 1 : UCIP\_479.jpg

Concrete block house with slide gate inside.

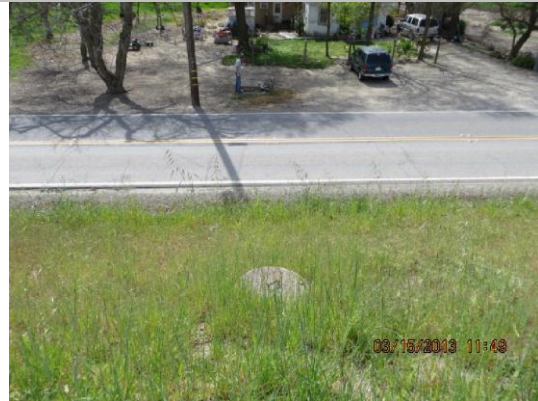
Photo 1 of 1 : UCIP\_338.jpg

Siphon Breaker in 25-inch CMP riser on LS slope with 4X4 concrete box off LS toe.

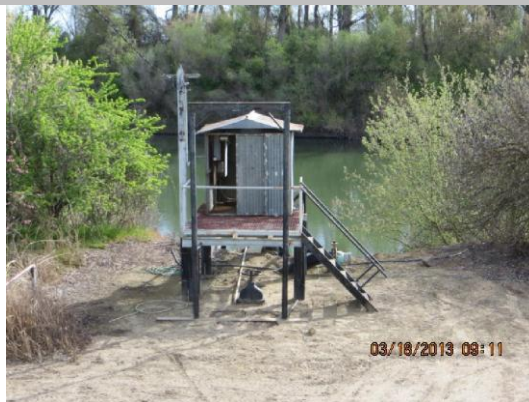
Photo 1 of 1 : UCIP\_341.jpg

Pump at WS berm.

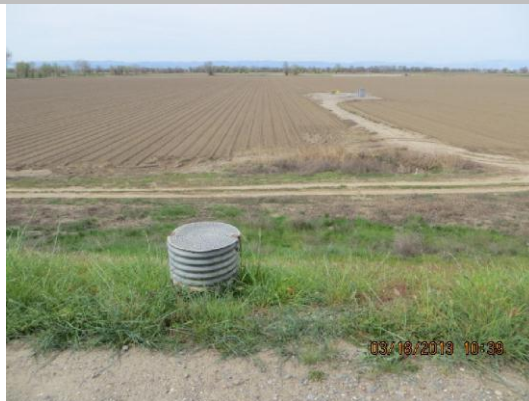
Photo 1 of 1 : UCIP\_342.jpg

Siphon breaker in 24-inch CMP riser on LS shoulder.

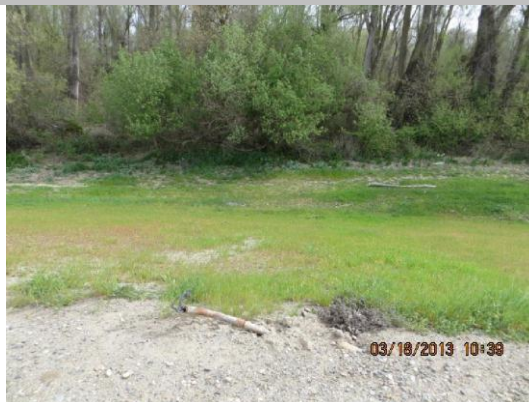
Photo 1 of 1 : UCIP\_344.jpg

Electrical conduit on WS shoulder.

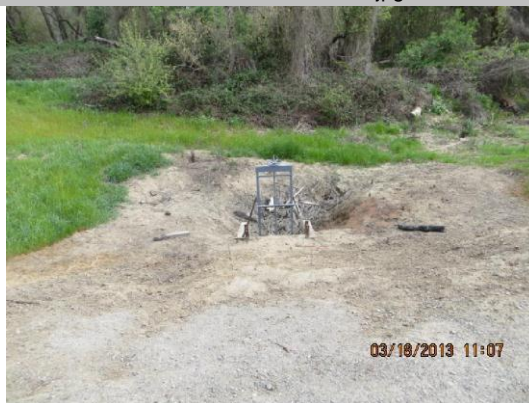
Photo 1 of 1 : UCIP\_347.jpg

Slide gate on WS toe.

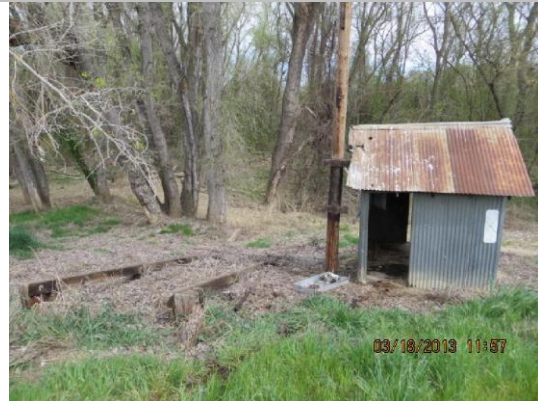
Photo 1 of 1 : UCIP\_349.jpg

Pump house, JP, and wooden ramp on WS slope.

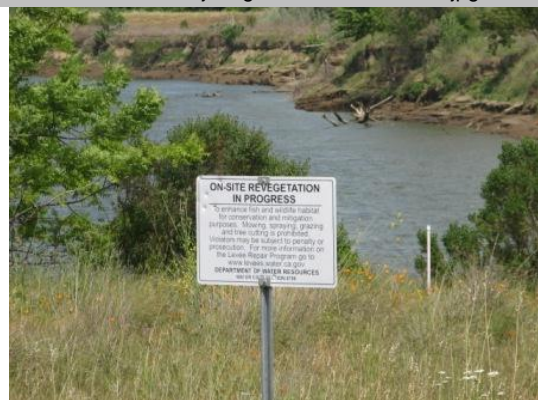
Photo 1 of 2 : johngw\_s\_20140414\_761.jpg

Revegetation site. Photo taken spring 2012.

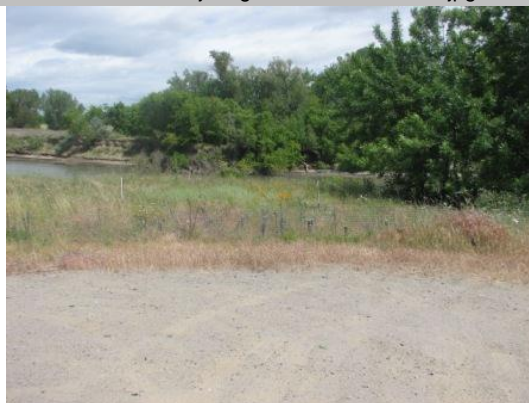
Photo 2 of 2 : johngw\_s\_20140414\_762.jpg

The revegetation on the berm with the fence and stakes.

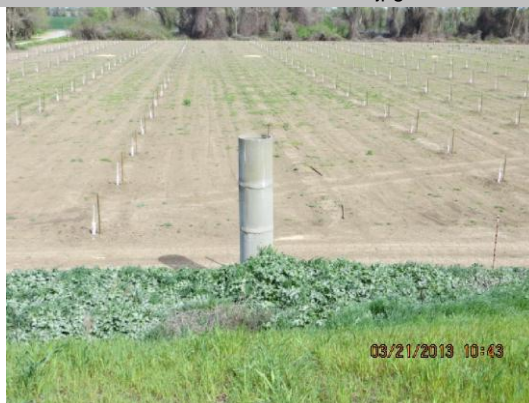
Photo 1 of 1 : UCIP\_456.jpg

Electrical conduit approximately perpendicular to concrete riser on LS toe.

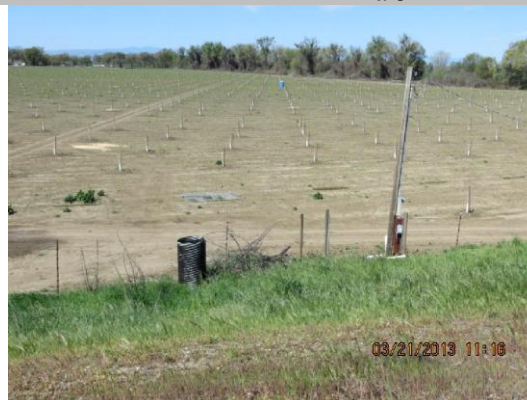
Photo 1 of 1 : UCIP\_353.jpg

30-inch CMP riser with slide gate at LS toe.

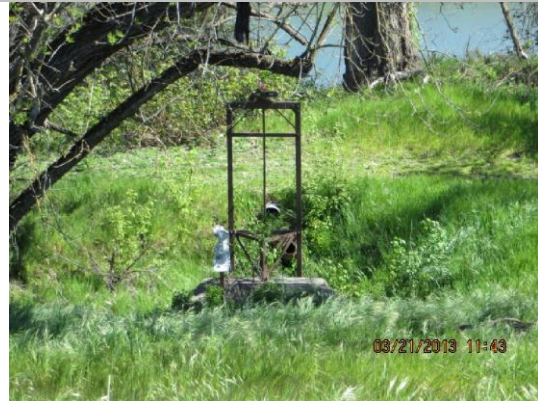
Photo 1 of 1 : UCIP\_360.jpg

Slide gate at WS toe.

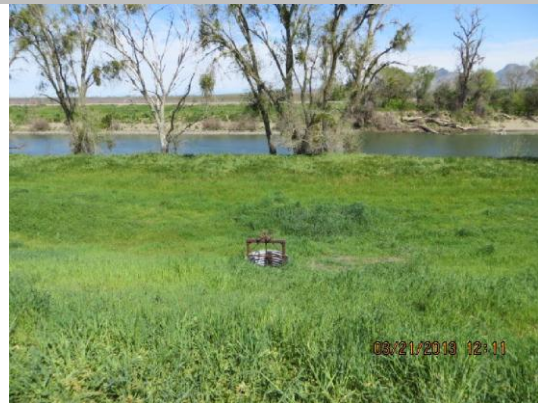
Photo 1 of 1 : UCIP\_365.jpg

Slide gate in CMP riser on WS toe.

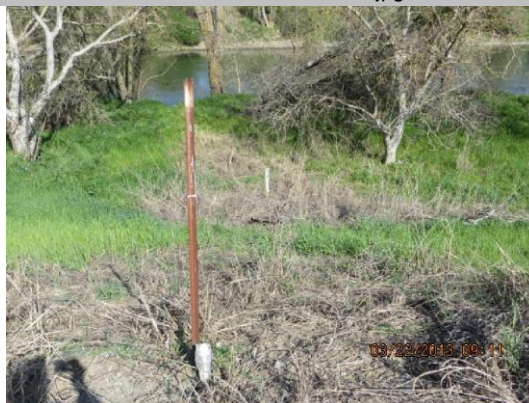
Photo 1 of 1 : UCIP\_371.jpg

Broken fresno valve on WS shoulder

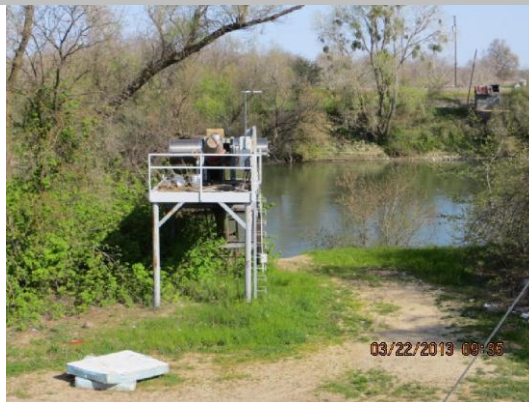
Photo 1 of 1 : UCIP\_373.jpg

Pumping plant on WS berm

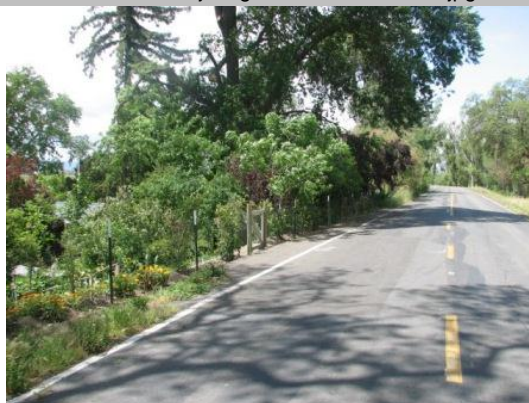
Photo 1 of 1 : johngw\_s\_20140414\_765.jpg

The front yard along the road and on the levee slope. Photo taken spring 2012.

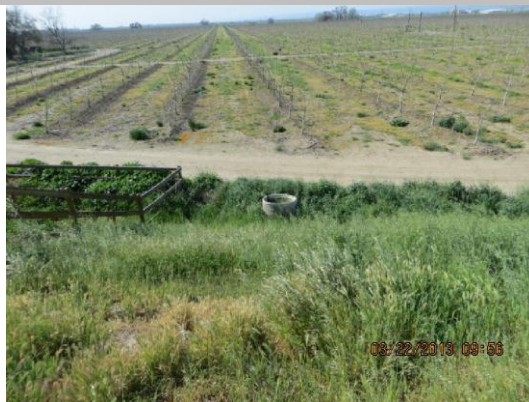
Photo 1 of 1 : UCIP\_377.jpg

Possible location for pipe crossing.

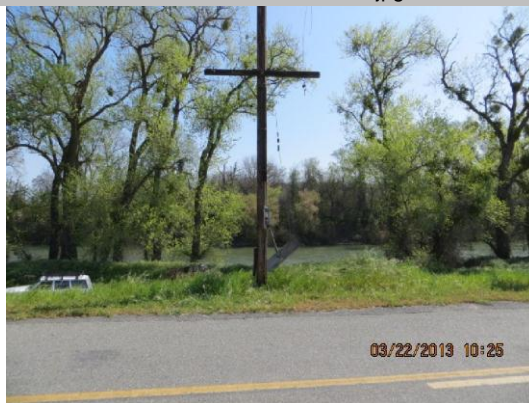
Photo 1 of 1 : UCIP\_378.jpg

JP on WS shoulder for removed pump switch house.

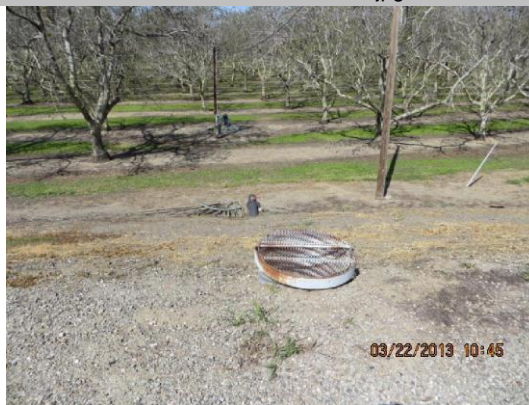
Photo 1 of 1 : UCIP\_382.jpg

Siphon Breaker in 30-inch CMP riser on LS shoulder and butterfly valve at LS toe.
